**USEPA - USGS - Montgomery County DEP
- UMBC - University of Maryland College Park
Collaborative Hydrological Research in the
Clarksburg Maryland Special Protection Area**

**Our Study Area is the
Clarksburg Special
Protection Area (CSPA)**

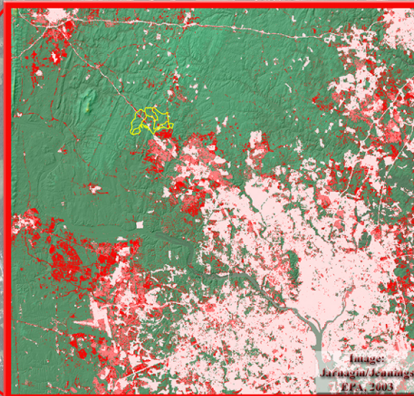
Satellite classification of urban land cover 1970s - 2000. The CSPA (yellow outline above) is at the outer edge of the current development extent of the core Washington DC metropolitan area. Image from EPA Science Forum 2003 poster: "Use of LIDAR to Monitor Stream Morphology Changes Due to Urbanization of a Suburban Watershed". S. Taylor Jarnagin and David B. Jennings, USEPA Landscape Ecology Branch, Reston VA 20192-0002.

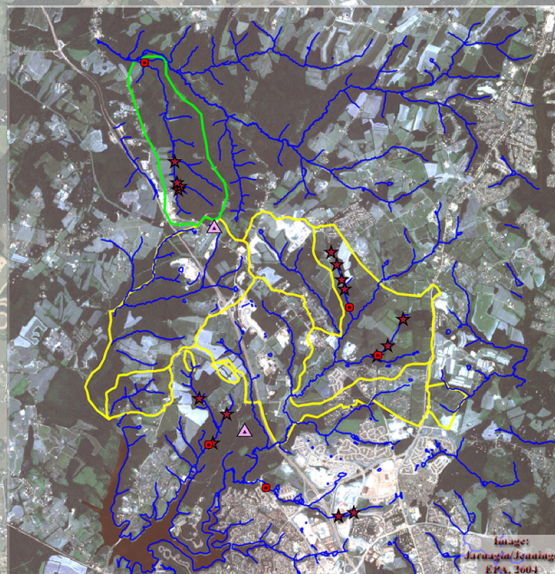
CSPA Streamflow and precipitation gages and monitoring locations. USGS WRD, University of Maryland College Park, Environmental Systems Analysis, M-NCPPC and Montgomery County DEP are collaborating on the collection of these data. The base map is an IKONOS 4-meter satellite image obtained in June 2002.

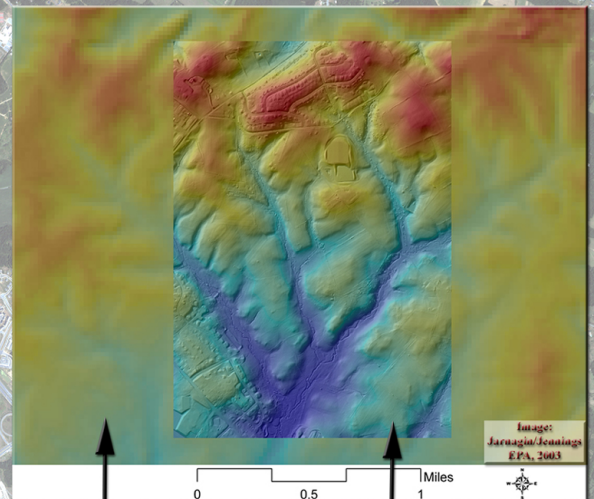
Shaded Relief from
National Elevation Data
(NED, 30 m DEM)

Shaded Relief from
LIDAR (0.5 m DEM)
